# Brighton Road

## Bridge Collision Protection Beams

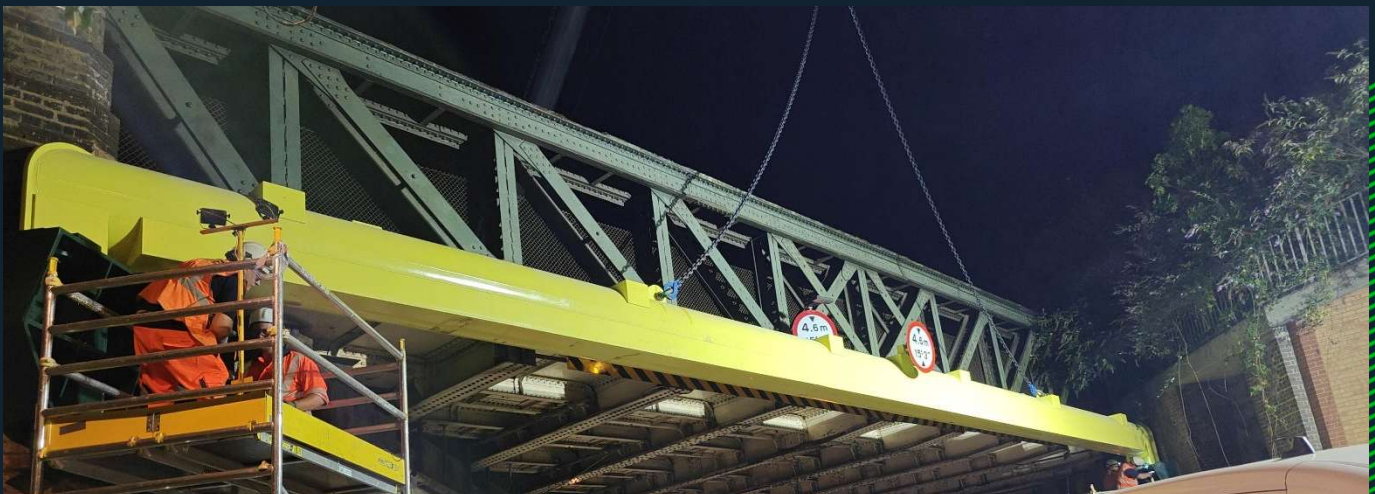
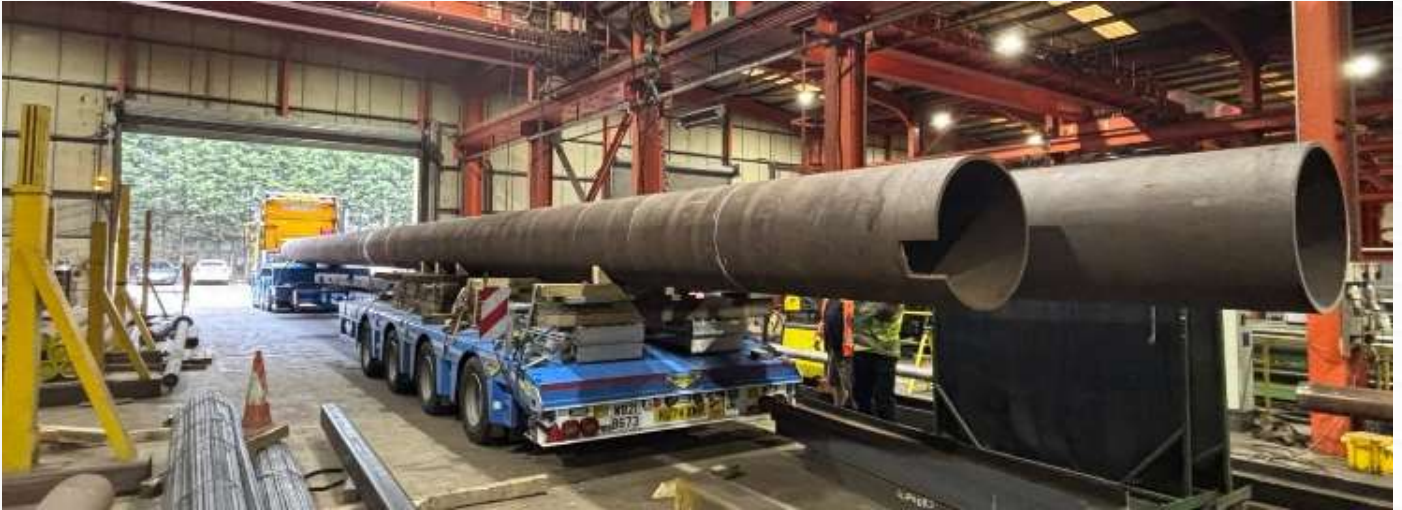
The two carefully detailed, fabricated and installed structural steelwork protection beams were 26.3m and 24.6m in length, both 744mm in diameter and totalling 27 tonnes of steel. The associated support structures, each weighing 2 tonnes, were also detailed and fabricated by FTE, giving a total of 35 tonnes of fabricated steelwork to protect Brighton Road Bridge from impacts.

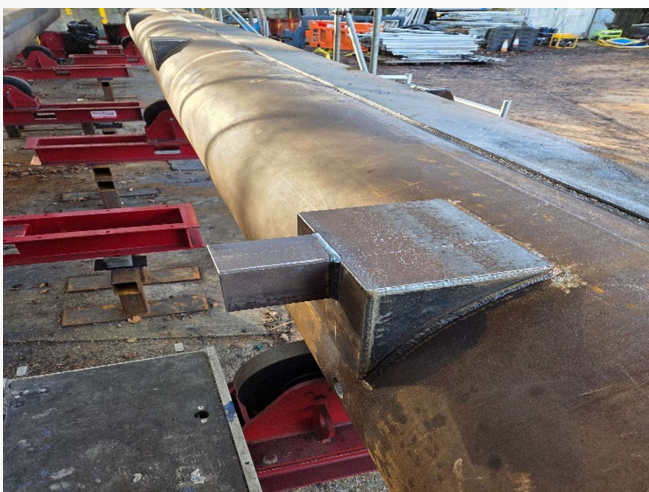
Due to the substantial clear span of the collision protection beams, they had to be pre-cambered before installation. This specialist operation was undertaken by Angle Ring: 36mm for the shorter beam and 74mm for the longer beam. This pre-camber

accounted for the weight of the beams and the weight of the concrete grout that would be used to fill the steelwork tubes once they were installed.
